Pentium® II Processor Specification Update

Release Date: September 1998

Order Number: 243337-018

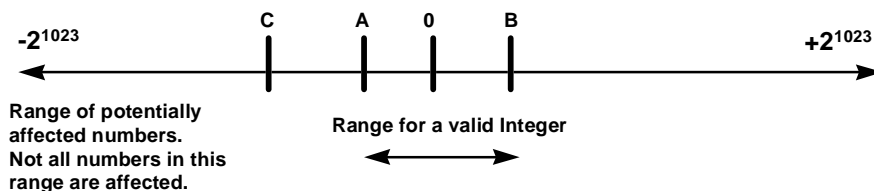
IMPLICATION: Erroneous operation results when the operand is so large that it will not fit into the target data size. The operands affected by this erratum are significantly outside (by a factor of 3X) the range that can be, correctly, converted to an integer value. The figure below and corresponding table identifies the normal range of integer numbers (between A and B) and the starting point of the operands affected by this erratum. Discrete failing operands will be present in the range between point C and the maximum negative number that can be represented by the processor (-2^{1023} in double precision format). Note 2 below gives a qualitative description of the nature of the discrete failing values. Software that does not rely on the Invalid Operation exception flag being set and signaled by either an exception OR by software polling is not impacted by this erratum.

16-bit Operation	A	B	C
	-32,768.0	+32,767.0	< -98304.0
32-bit Operation	A	B	C
	-2,147,483,648.0	+2,147,483,647.0	< -6,442,450,944.0

WORKAROUND: Any of two software workarounds will avoid occurrence of this erratum:

- Range checking performed prior to execution of the FIST[P] instruction will prevent the overflow condition from occurring, and may already be implemented as a coding style.
- Software can use the presence of MAXNEG in the result integer to indicate that an out of range conversion may have occurred.

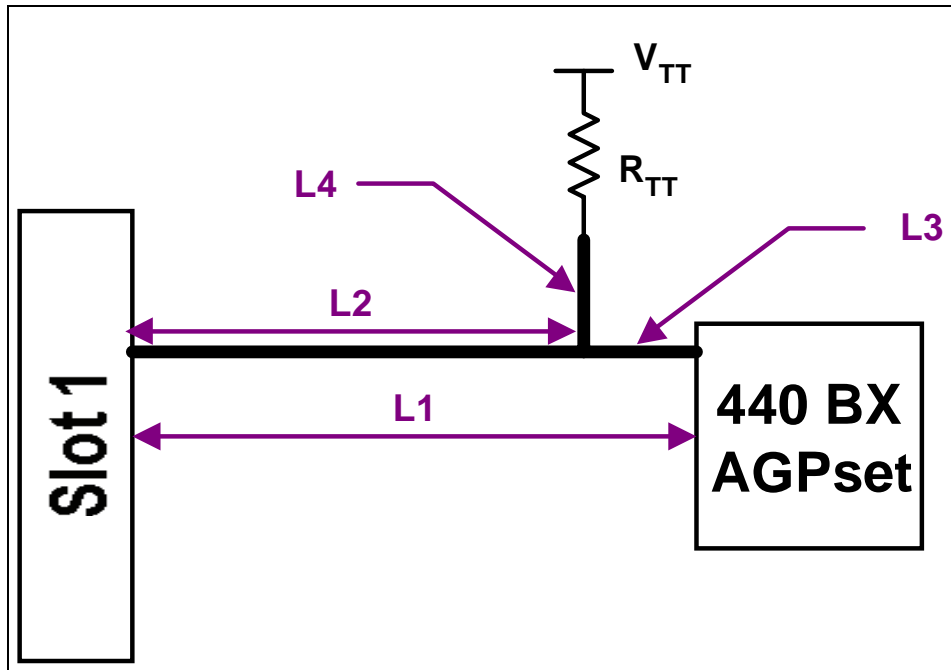
Figure 1. UP Dual Ended Termination (DET)

For UP-DET topologies (see Figure 1), the trace length $L1$ must be between 1.5" to 4.5" while using a 56 Ω termination resistor.

WORKAROUND: If the chipset and third party agents used with the Pentium II processor do not optimize their arbitration latency as described above, no action is required. For the 66 MHz Pentium II processor, no action is required. If agents that have implemented this optimization, by following the *100 MHz GTL+ Layout Guidelines for the Pentium® II Processor and Intel 440BX AGPset* for UP-SET (single-ended termination) and DP with both processors installed, no action is required. The following two cases are additional guidelines for UP-DET (dual-ended termination) and DP-DET with only one processor populated.

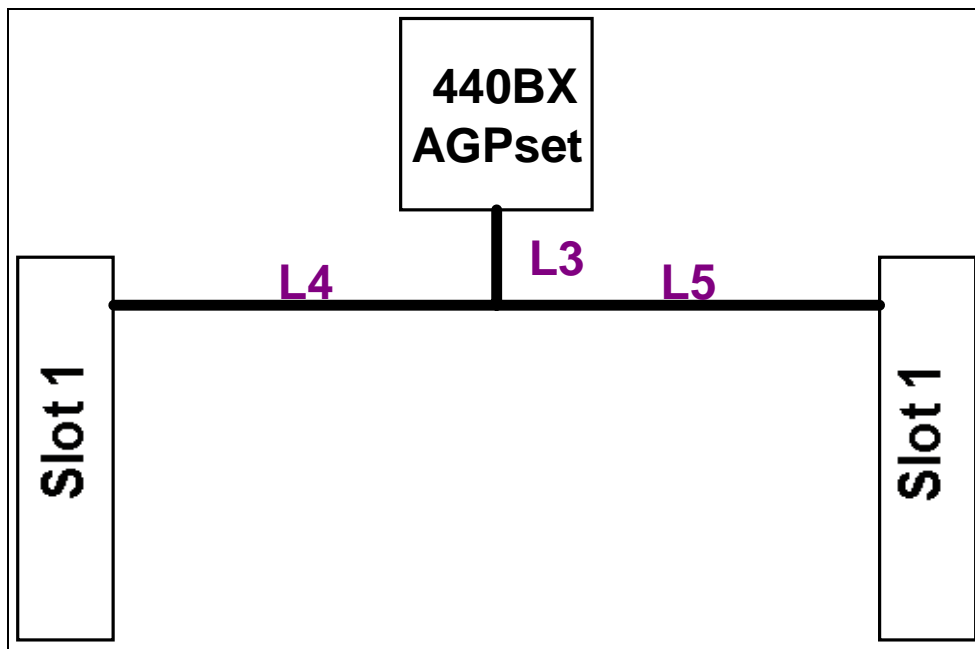
Figure 2. DP Dual Ended Termination (DET)

For DP topologies (see Figure 2) installed with a processor and a termination card, $L4 + L3$ or $L5 + L3$ must be less than or equal to 4.5". Additionally, for DP platforms with one processor installed, the termination card should be placed in the longer leg.

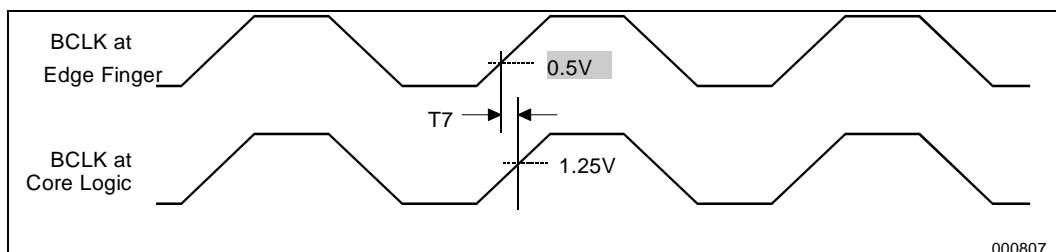
Figure 6. BCLK to Core Logic Offset

In Figure 6 of the *Pentium® II Processor at 233 MHz, 266 MHz, 300 MHz, and 333 MHz* datasheet, the following changes should be made:

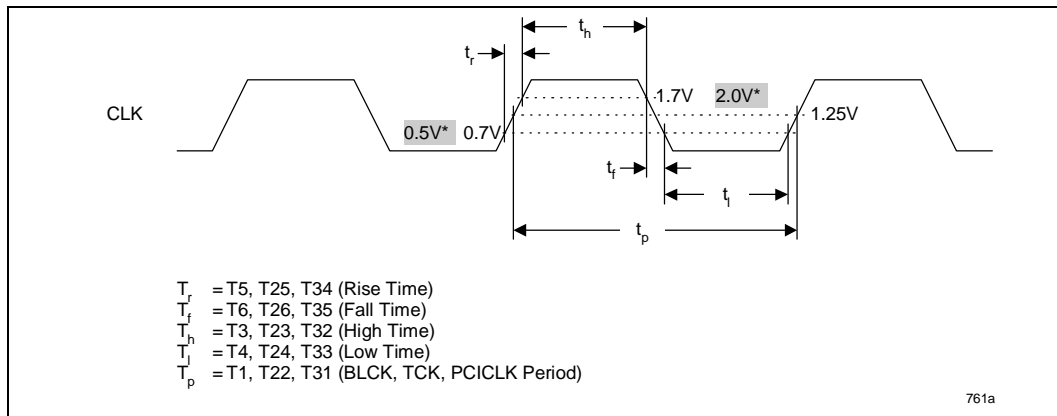
Figure 7. BCLK*, PICCLK, and TCK Generic Clock Waveform

In Figure 7 of the *Pentium® II Processor at 233 MHz, 266 MHz, 300 MHz, and 333 MHz* datasheet, the following changes should be made:
